Shoreline Stabilization Projects

Greg Berg – Stearns County SWCD 320/251-7800 Extension # 143 greg.berg@mn.nacdnet.net www.stearnscountyswcd.net

Shoreline Example # 1 - Existing Property Conditions

Project Example # 2 – Sauk Lake

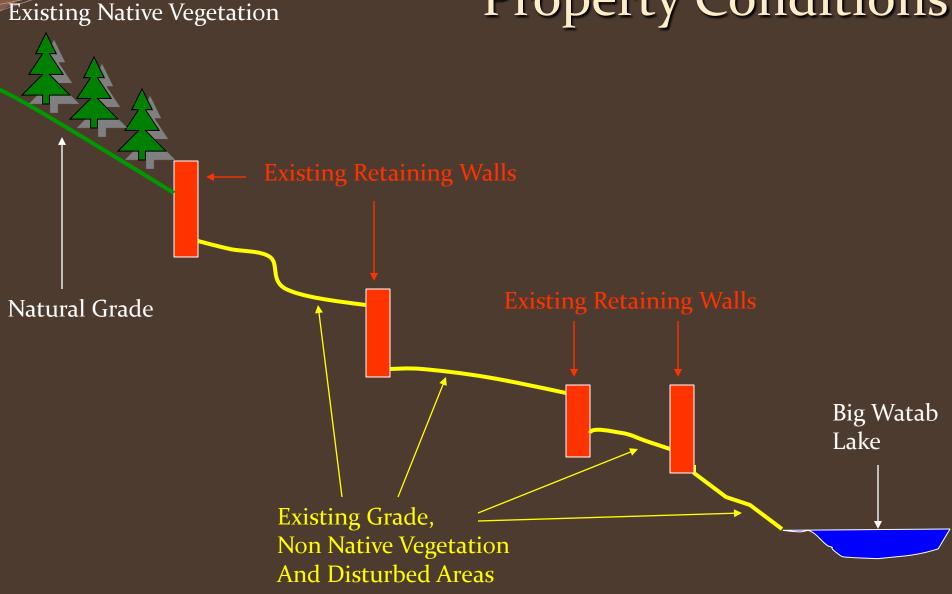
Not to scale
